Manhole Inspection Summary

Manhole # S25Q__008MH

Insp Date: **4/9/08 12:47 PM**

Location Address: **1515 WASHINGTON BLVD.**

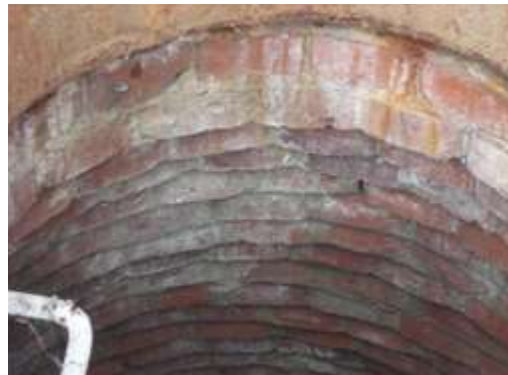
Defect 5

Condition: ☐ Sound ☐ Cracked ☐ Root Intrusion ☐ Loose Brick ☒ **Deteriorated**

chimney deteriorated

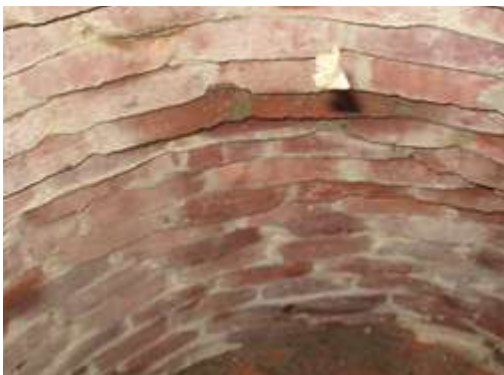
Defect 4

Infiltration: ☐ None ☐ Joint ☐ Cracks ☒ **Mortar** ☐ Roots ☒ **Wall**

corbel infiltration at mortar/wall

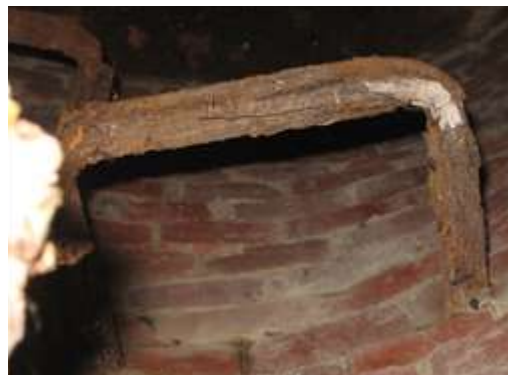
Defect 3

Count: **3** Missing: **0** ☒ **Corroded**

corroded rungs

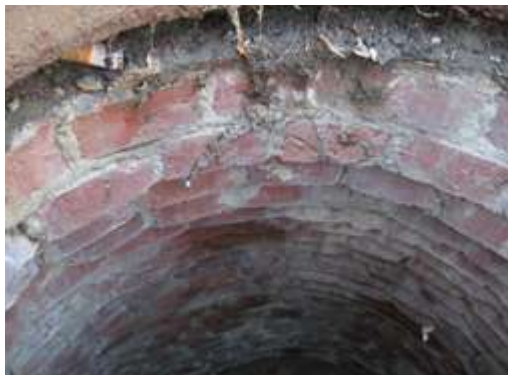
Defect 2

Infiltration: ☐ None ☒ **Joint** ☐ Cracks ☐ Mortar ☐ Roots ☐ Wall

infiltration from joint frame-chimney

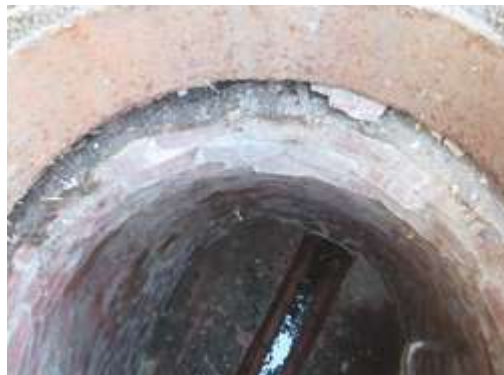
Defect 1

Offset: **0.5** (in.)

offset

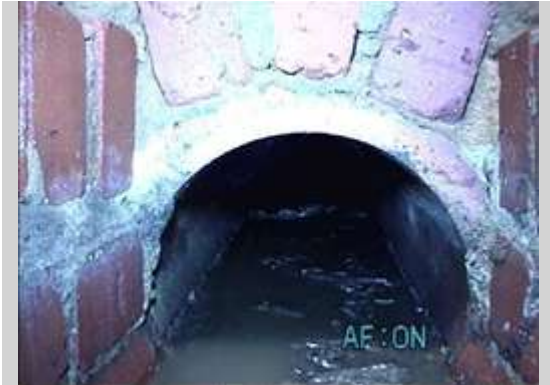
12 O'Clock Outflow

Pipe Height: **8.4** (in.) Rod and Bar (Angled)
Pipe Material: **Clay** ☐ Pipe Lined
Invert Depth: **7.00** (ft.) Flow Characteristics: **Slow**
Deposits: ☒ None ☐ Mud ☐ Sludge ☐ Debris ☐ Grease
Silt Depth: **0** (in.) Deposits Extent:
Infiltration: **Evidence** Pipe Seal Cond: **Unknown**

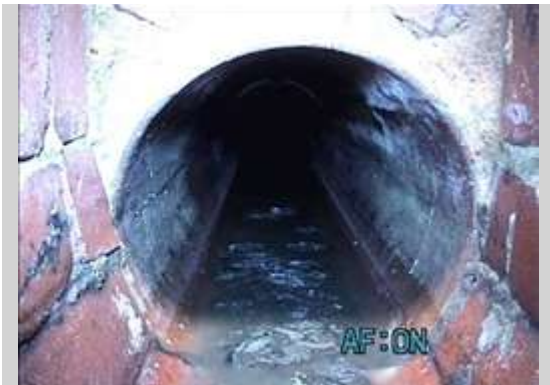
6 O'Clock Inflow

Pipe Height: **8.4** (in.) Rod and Bar (Angled)
Pipe Material: **Clay** ☐ Pipe Lined
Invert Depth: **6.99** (ft.) Flow Characteristics: **None**
Deposits: ☒ None ☐ Mud ☐ Sludge ☐ Debris ☐ Grease
Silt Depth: **0** (in.) Deposits Extent:
Infiltration: **None** Pipe Seal Cond: **Sound**
